# **Characterization of High Temp Thermal Sprays for Engine Applications**

Nick Jacobs – UDRI

Presented at HCAT – Kennedy Space Center

November 19, 2003

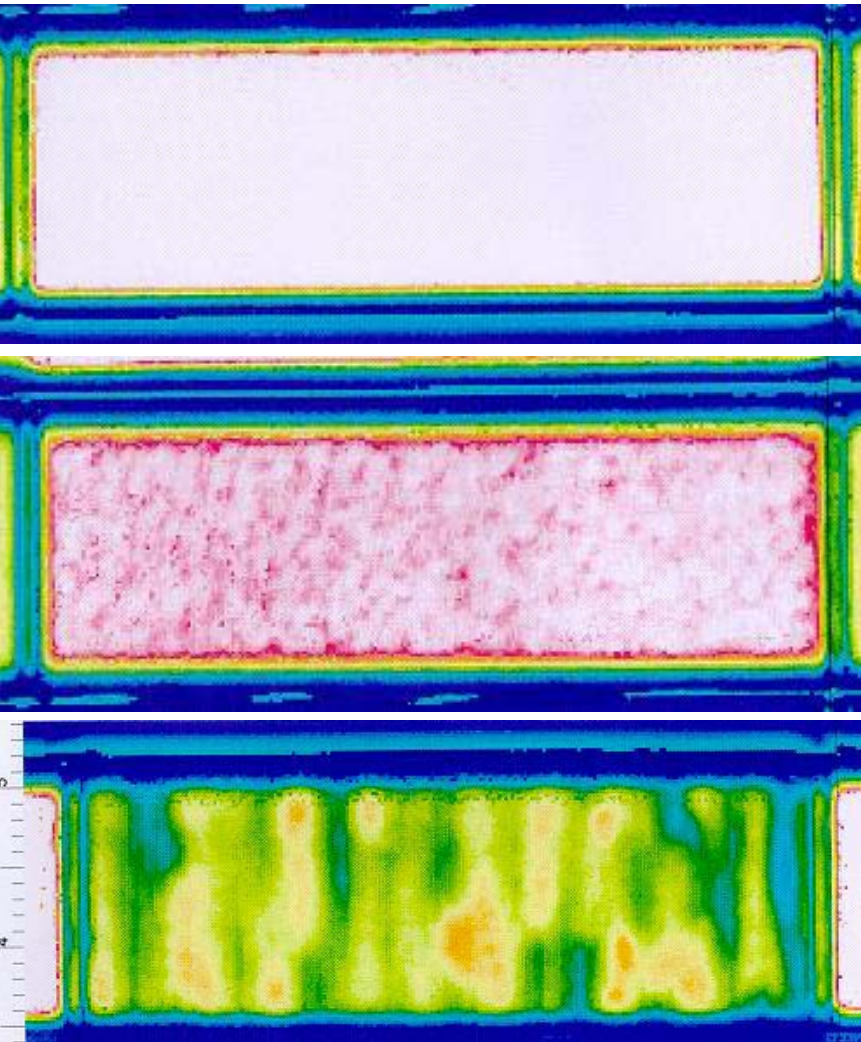
### NDI Scans

Baseline NDI scans performed on undamaged specimens, some scans show uniform attenuation (gain issues)

Post Damage, some NDI scans show “Uniform Attenuation” and surface shows no visible coating damage – *Almost all coatings*

Post Damage, *PS WC-Co17* shows visible cracking on coating surface, NDI scans show definite loss of coating integrity

- HVOF sprayed coatings
  - Tribaloy-400 showed unstressed cohesive failures – increasing with stress
  - WC-Co17 showed slight effect of damage increasing with cycles
  - Ni,Cr showed slight effect of damage increasing with cycles
- As-sprayed PS adhesion was poor
  - WC-Co17 showed effect of damage as cycles and stress increased
  - Tribaloy-400 failed as low as 34% of typical HVOF adhesion results
- NDI results
  - Ultrasound scans (baseline vs. damaged) only correlated for visibly damaged coatings

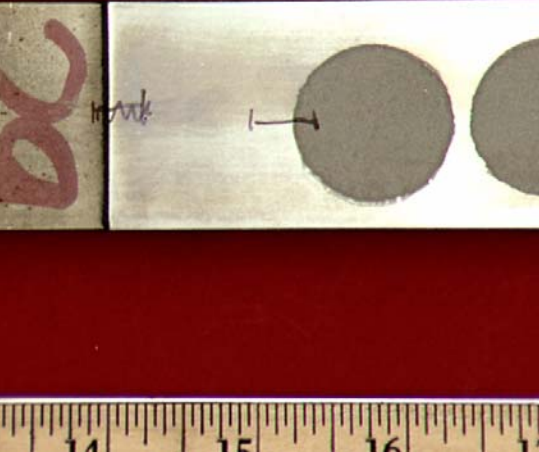
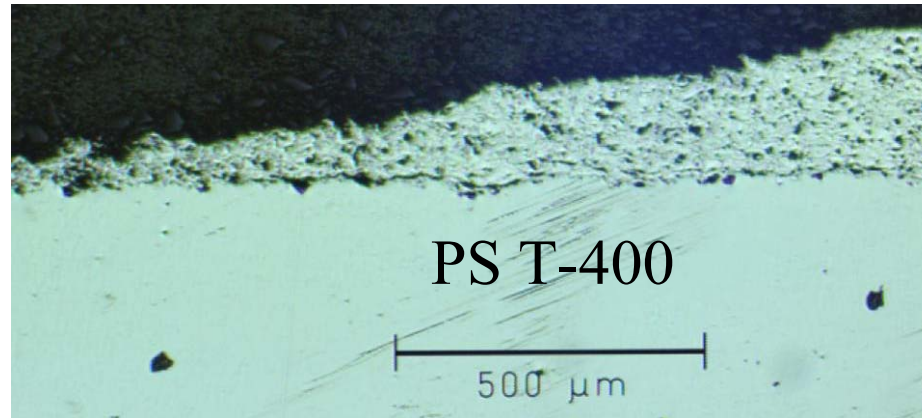
# Metallography

## *Thick Coatings*

*Low angle fail,  
porosity*

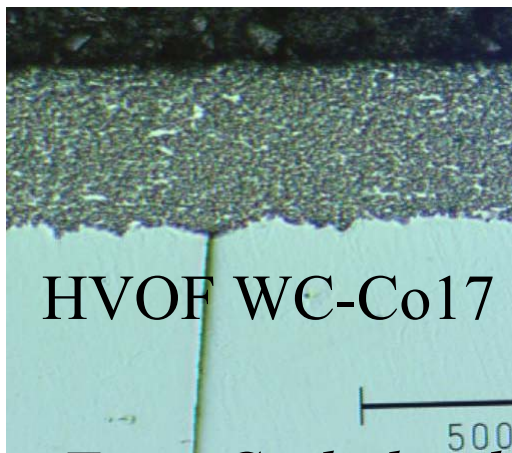
*Finer Carbides, less  
Porosity*

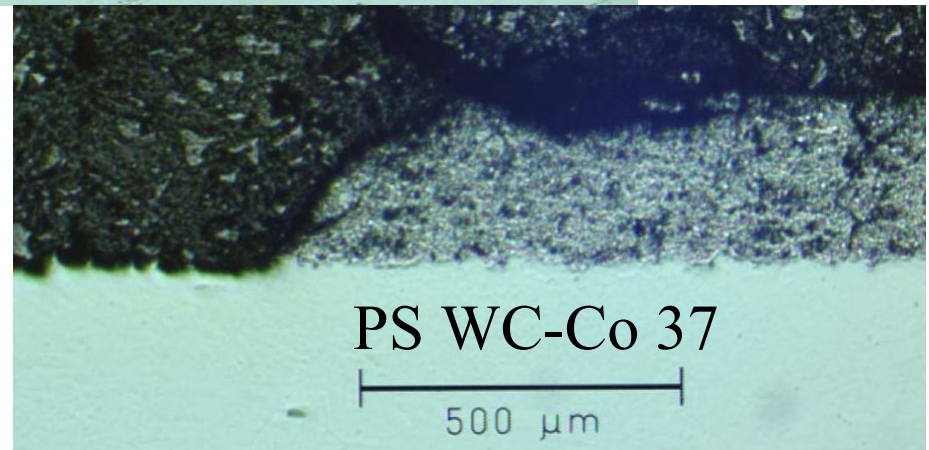
*Porosity, larger carbides*

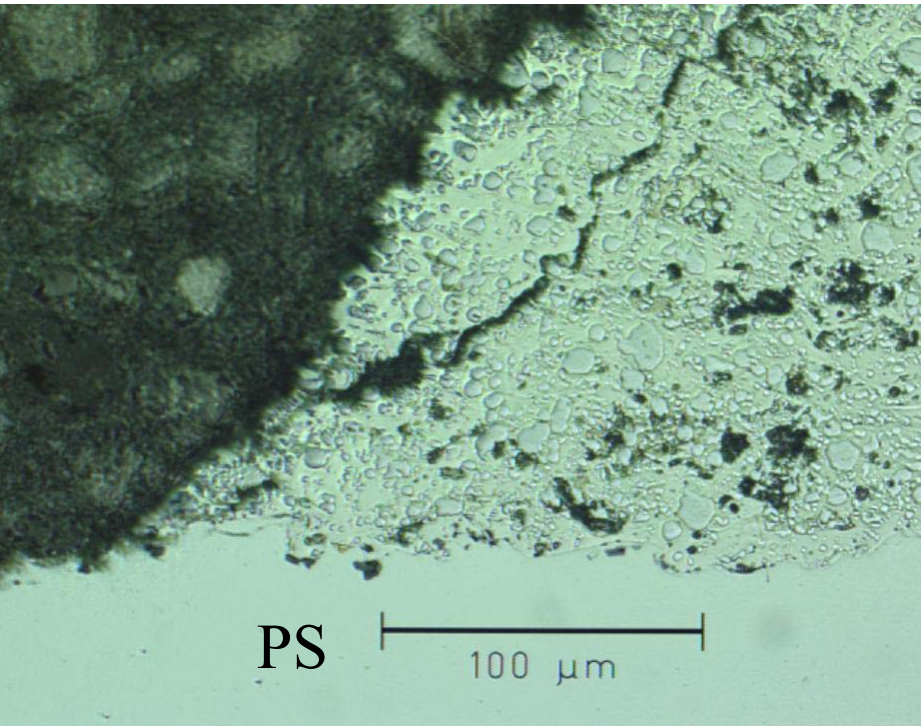
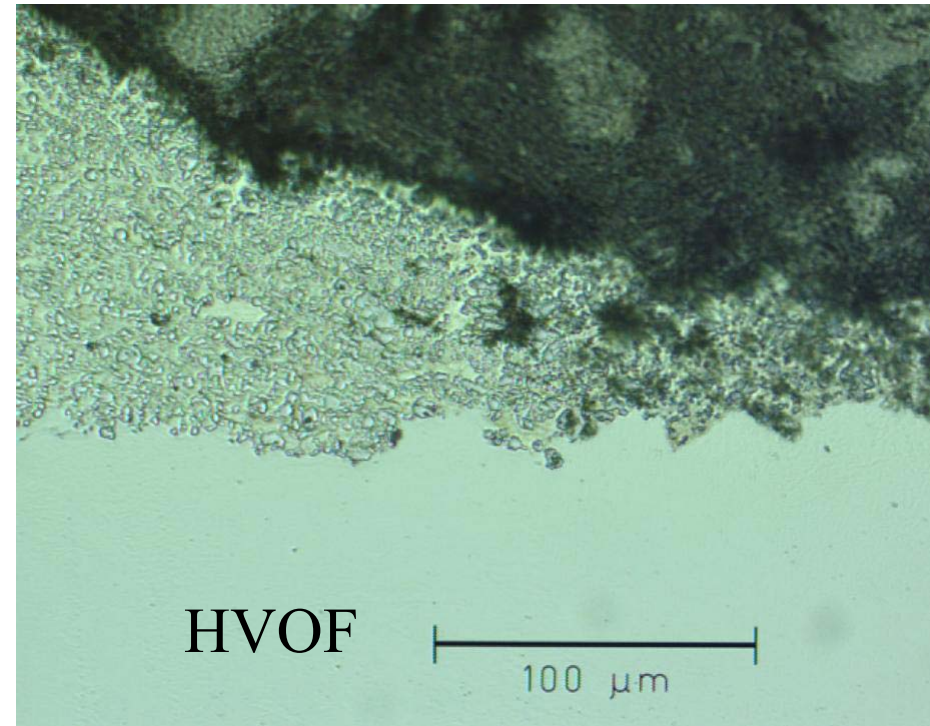
# Metallography

## *WC-Co17 Coatings*
